20. ABSTRACT (Continue on reverse side if necessary and identify by block number) Mary's Creek Watershed Dam No. 8 is a curvilinear earthen structure 1120 feet long and 30.0 feet high with a crest width of 12 feet. The upstream and downstream slopes are 1V:2.4H and 1V:3.5H respectively. At normal pool, the 25 acre lake has a storage capacity of 149 acre-feet. At the top of the dam the pool area increases to 45 acres with an impoundage of 380 acre-feet. The drainage area for the lake is 286 acres. It is predominantly pasture and woodland with an average ground slope of approximately 5.6%. The dam is uniform, well grassed, and clear of any deleterious vegetation. The upstream

Based upon the inspection and subsequent evaluation, Marys Creek Watershed No. 8 is classified as deficient due to insufficient storage and spillway capacity to pass the one-half probable maximum flood and minor erosion of the dam.

MARY'S CREEK WATERSHED DAM NO. 8
SHELBY COUNTY
MARCH 27, 1981

PHASE I INSPECTION REPORT
NATIONAL DAM SAFETY PROGRAM
TENNESSEE

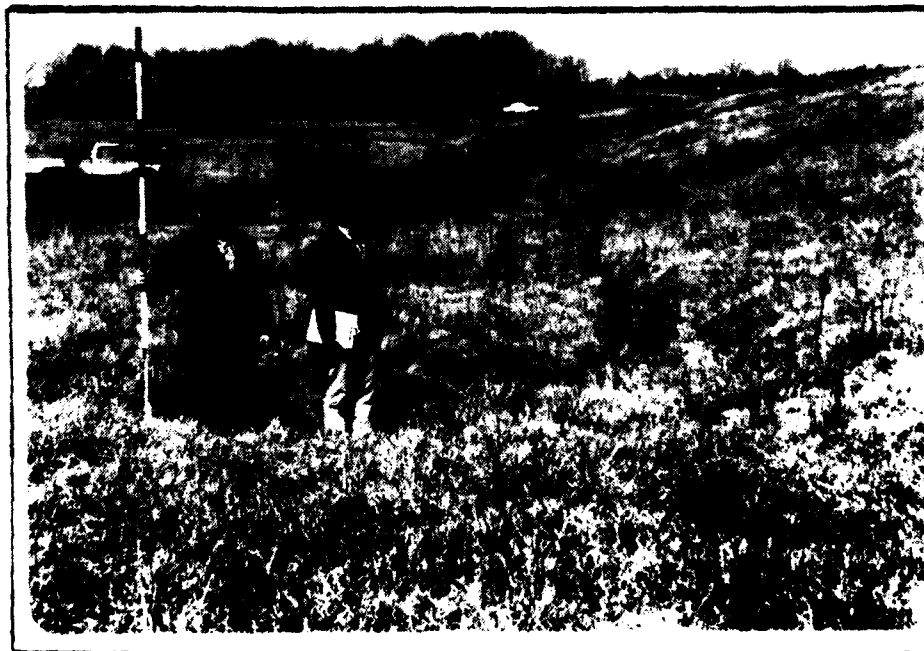
PHOTO NO. 8

- Photo No. 7 - Riser.
- Photo No. 8 - Downstream of toe showing excavated drainage ditch.
- Photo No. 9 - Sloughing along upstream slope just right of emergency spillway.
